ACOUSTICAL AND VIBRATIONAL STUDIES
RELATING TO AN OCCURRENCE OF SONIC BOOM INDUCED
DAMAGE TO A WINDOW GLASS IN A STORE FRONT

By Richard L. Lowery and Don K. Andrews

Prepared under Contract No. NAS1-5813 by
ANDREWS ASSOCIATES, INC.
Oklahoma City, Oklahoma

GPO PRICE \$ NATIONAL AERONAUTICS AND SPACE ADMINISTRATION

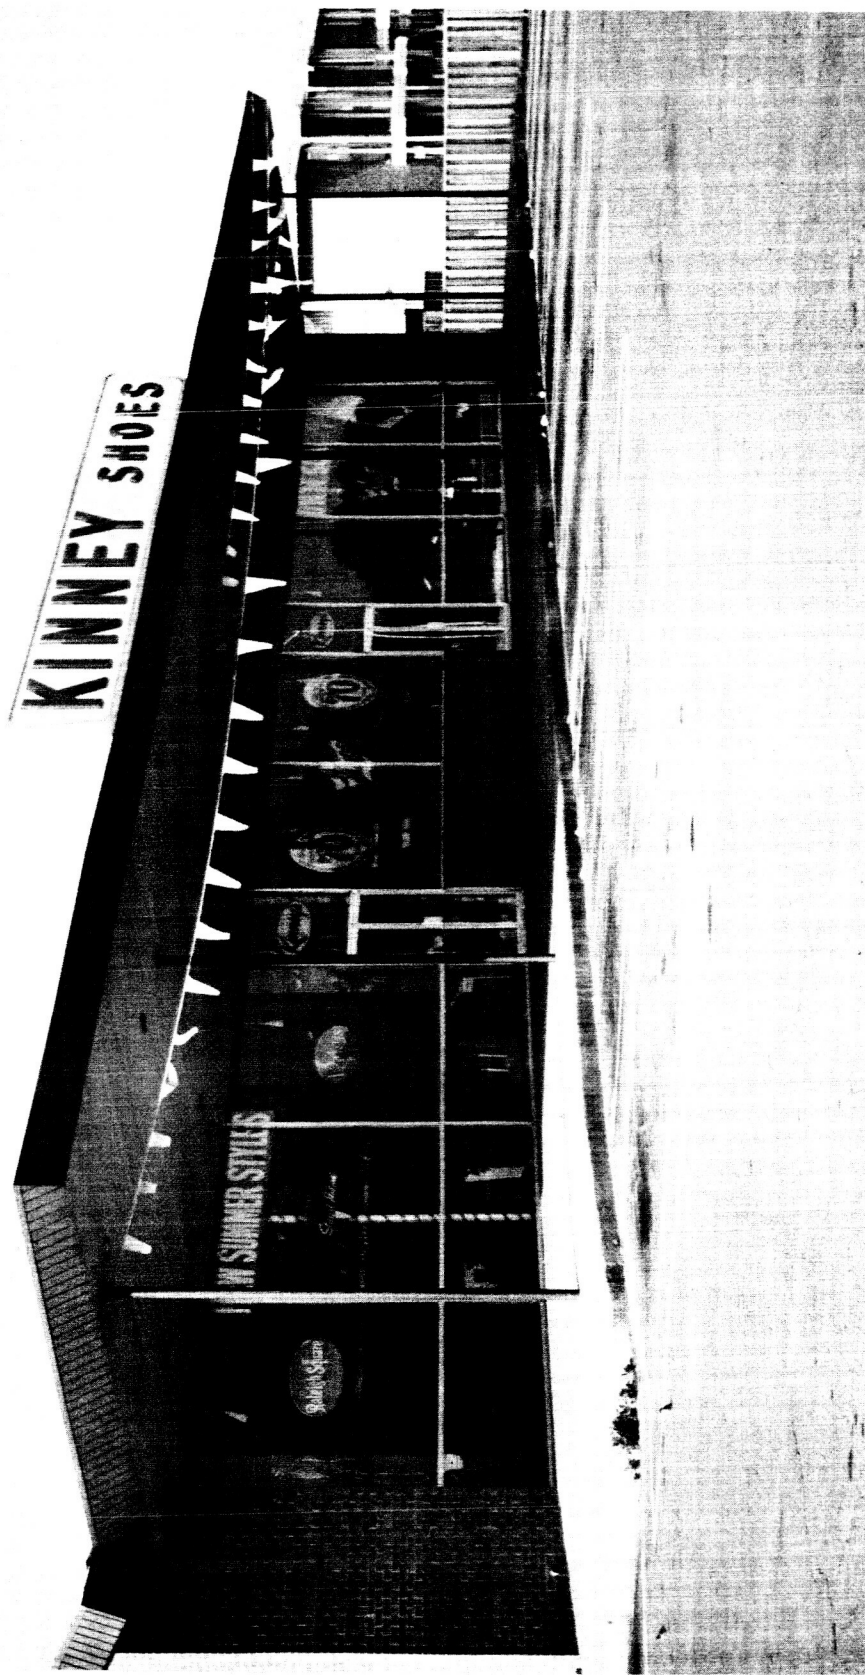
During the series of 1,253 sonic boom test flights conducted in the Oklahoma City area during 1964, an 8' x 10' x 1/4" plate glass window in the store front of a single-story commercial building was broken coincidentally with the occurrence of one of the sonic booms. See Figure 1. The glass breakage was witnessed by several persons and the newspaper accounts of the incident, including statements of these witnesses, are shown in Figure 2.

Figure 1 - Store front of the commercial building in which an 8' x 10' x 1/4" window glass was broken coincidentally with occurrence of a sonic boom. Third large pane from right is the location of broken window.

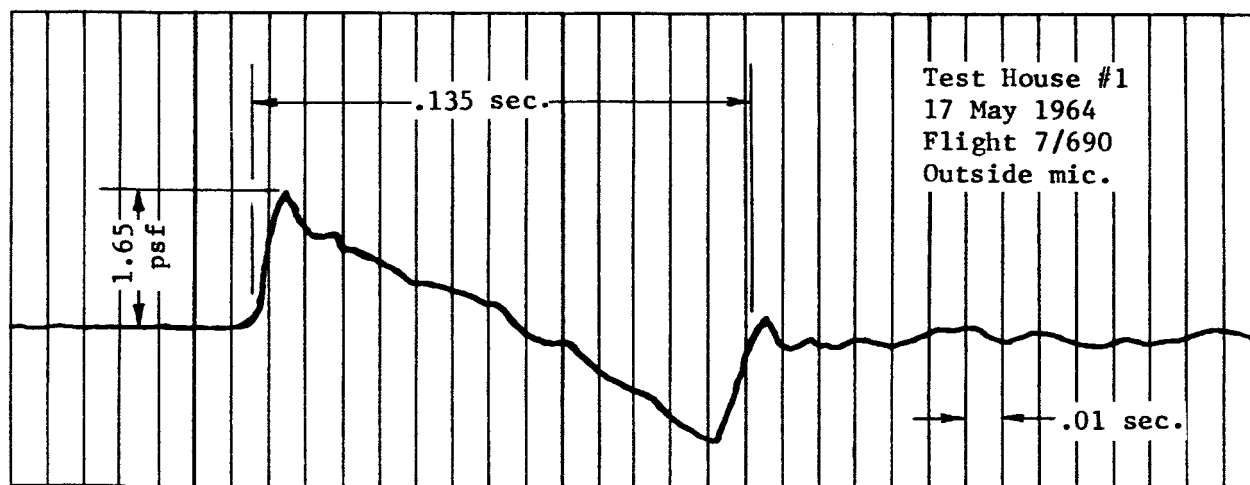
This particular sonic boom (#690 of the series) occurred at about 1:20 p.m. on Sunday, May 17, 1964 and was produced by an F-101 aircraft at 40,000 feet altitude on a scheduled steady-state course at a scheduled speed of Mach 1.4. The nearest location at which a pressure-time measurement of the boom was recorded was at a location designated as Test House #1. This location was about 5 miles northeast of the store building as shown in Figure 3. A copy of the pressure-time measurement recorded at Test House #1 for this flight is shown in Figure 4.

Figure 4 - Tracing of oscillograph tape of pressure-time record measured at a location on the ground in back yard of Test House #1.

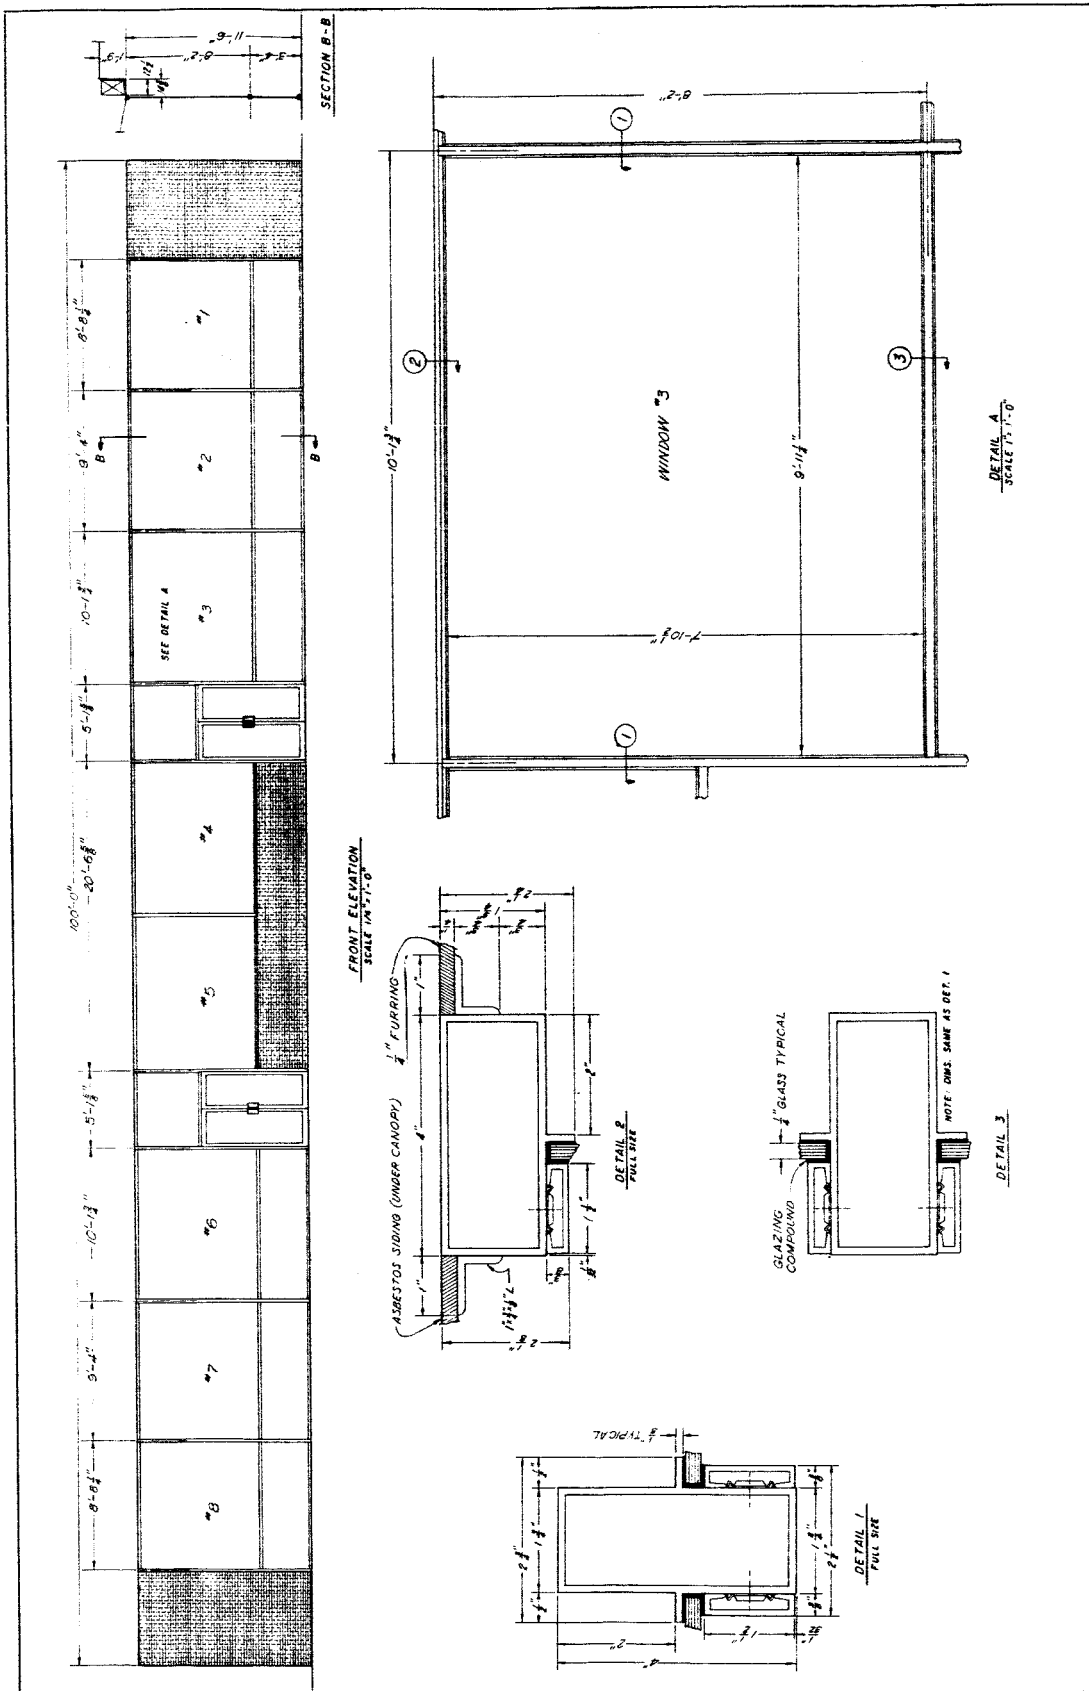
The windows in the front of the building are mounted in flexible mullions as shown in Figure 8. Window #6, the left-hand duplicate of Window #3, was disassembled to determine method and general quality of glazing practice for this

store front installation. Glazing practice was found to be in accordance with accepted standards. When one window is excited by transient force, the other windows adjacent to it also vibrate. Although individual natural frequencies of the separate panes can be excited in any free vibration recording, the existence of beats can be seen between the adjacent windows. Hence, it is virtually impossible to arrive at an exact mathematical model.

Figure 8 - Store front and window mounting details. Note window reference numbers. Window #3 is location of pane broken on May 17, 1964.

4. The original window was not glazed properly and glass to metal contact existed at one side or in one corner. This type of mounting can result in very high localized stresses which would precipitate failure. Also, since this is a very large window permitting large deflections of the center, if the window were not cut to fit the frame exactly, there is a possibility that a large deflection might cause one edge to come out of its mullion which, of course, would result in an increase in stress. (Note: The fact that Window #6, the left hand duplicate of Window #3, was found to be properly glazed as reported in Structural Considerations section of this report does not, of course, rule out the possibility of improper glazing of Window #3.)

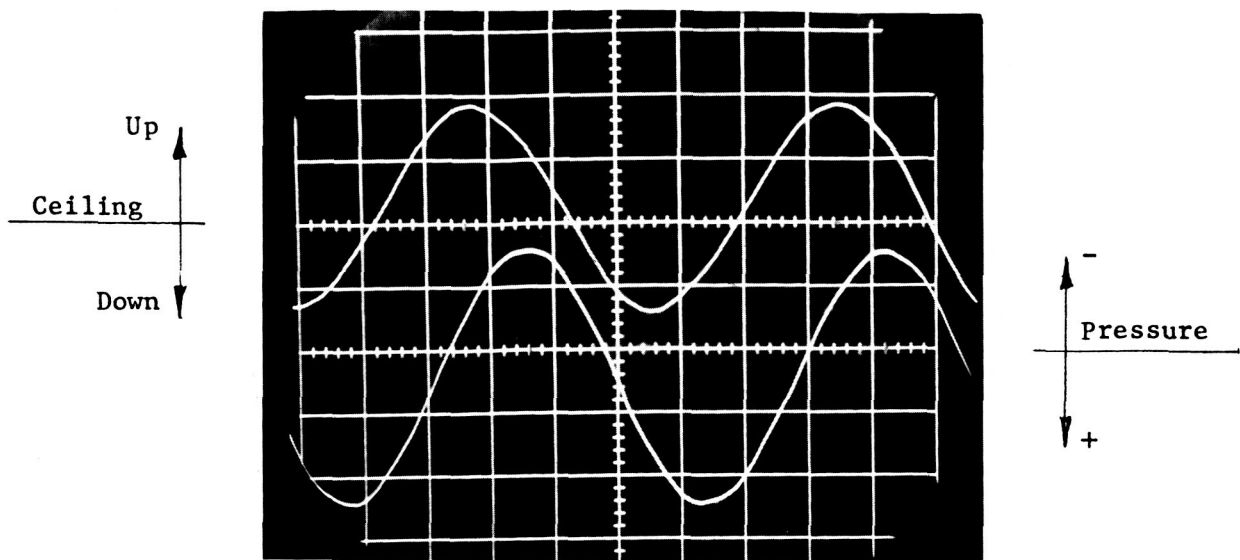
Figure 10 is an oscillogram of the ceiling motion (top trace) and the pressure (bottom trace). The phase shift present can be attributed to the velocity transducer, viz. 60 degrees lag at 8 cps. The peak displacement of the ceiling is about .0025 in. and the pressure is about .017 psf, at a frequency of 9 cps.

Figure 10 - Oscillogram of ceiling motion (upper trace) and interior air pressure (lower trace).

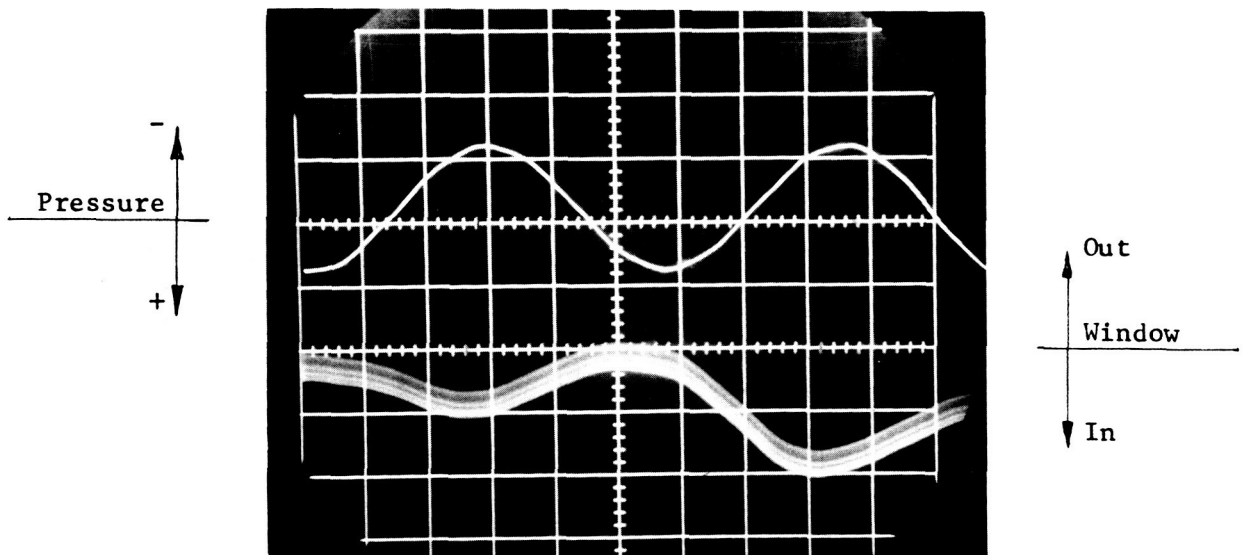
Figure 11 is a recording of pressure (upper trace) and window motion (bottom trace). The width of the bottom trace is due to a lack of complete filtration in the discriminator of the differential transformer. The pressure is .017 psf and the motion of the window is .006 in. at a frequency of 9 cps. Figures 10 and 11 were recorded at the same time so the values can be compared. The respective polarities of the recordings are shown in sketch below. Hence, as the ceiling moves about .0025", the pressure, in phase, is .017 psf and the window moves out .006". The motion of the center of the window would be somewhat greater, probably around .007".

Figure 11 - Oscillogram of interior air pressure (upper trace) and window motion (lower trace).

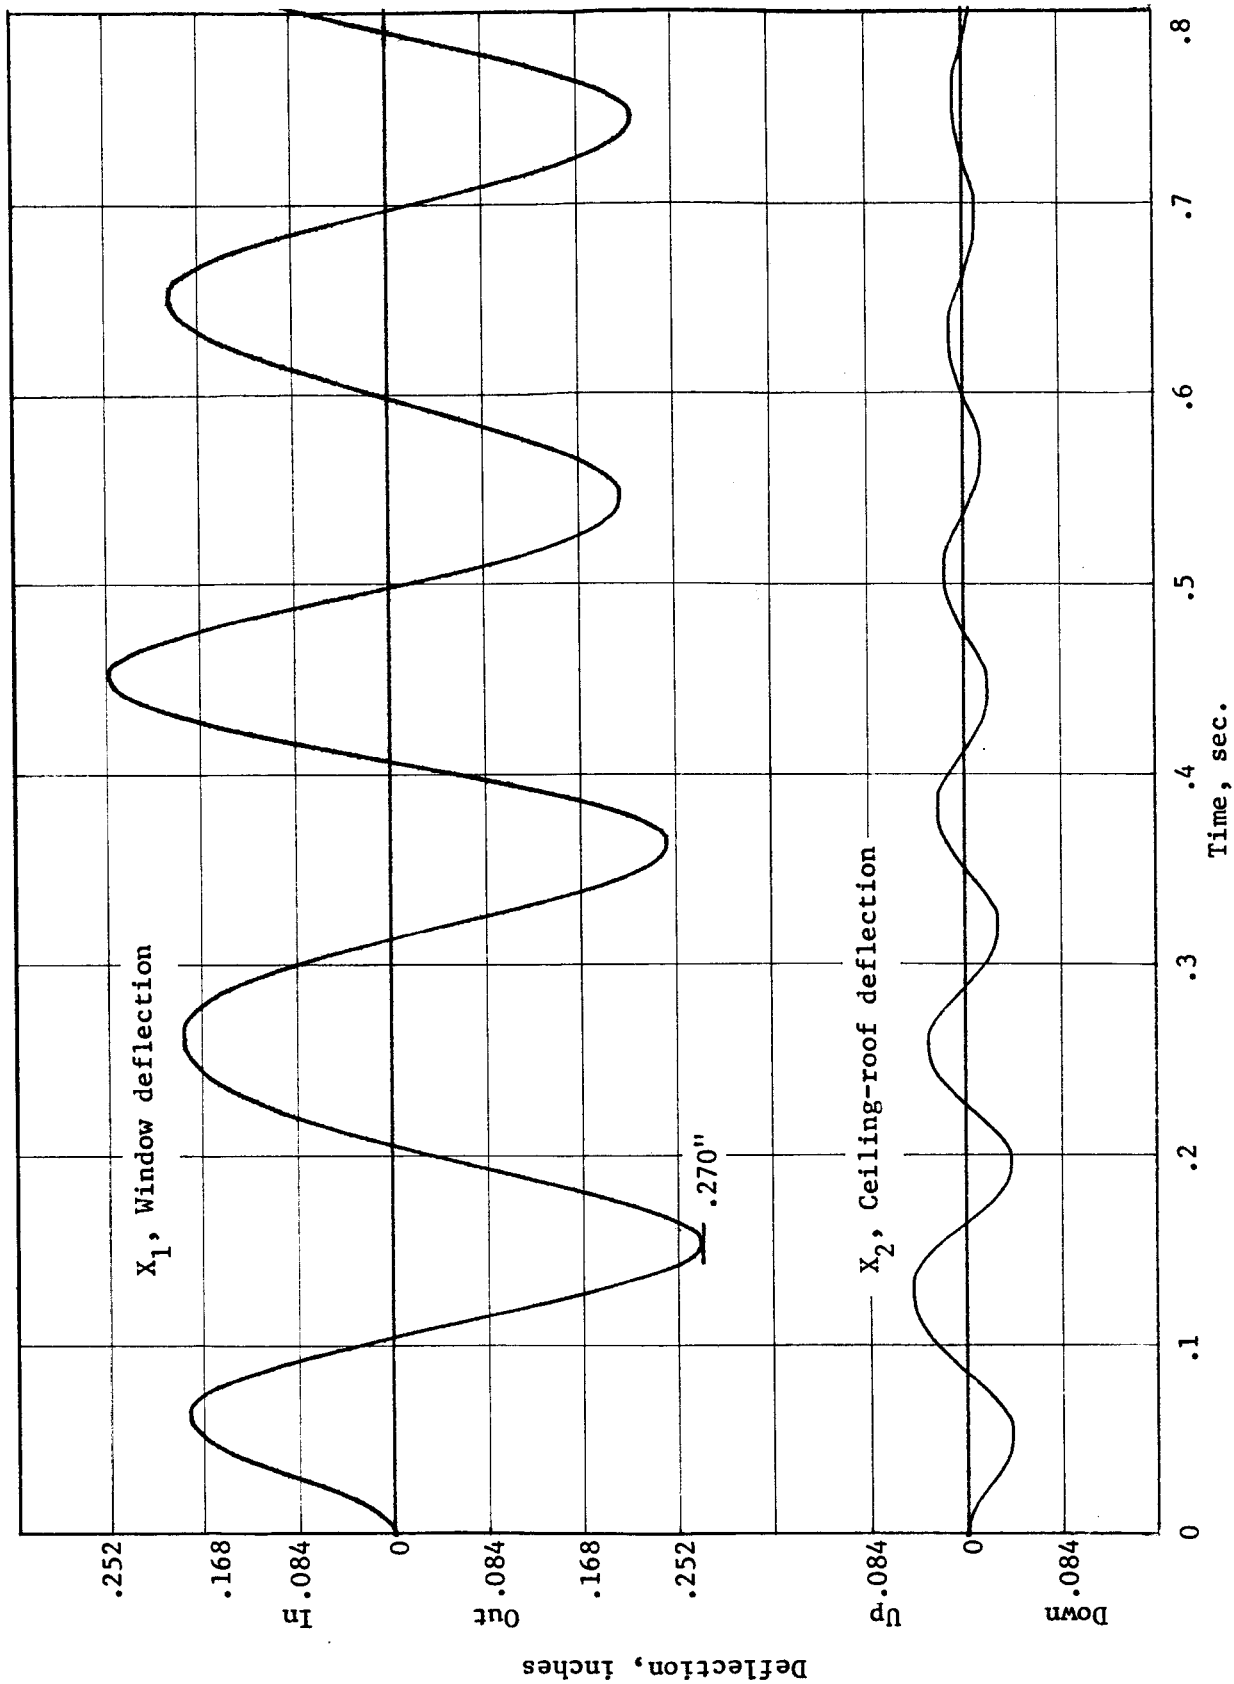
The major significance of this record is that the peak window displacement occurs at $t = .365$ sec. or about .230 second after the end of the force era, indicating that energy was being fed in from the more massive ceiling-roof assembly. Since the uncoupled natural frequencies are so far apart, however, very little energy interchange can take place.

Figure 13 - Computed window and ceiling-roof response for given N wave. Damping ratio $\zeta_1 = .01$, $\zeta_2 = .05$.

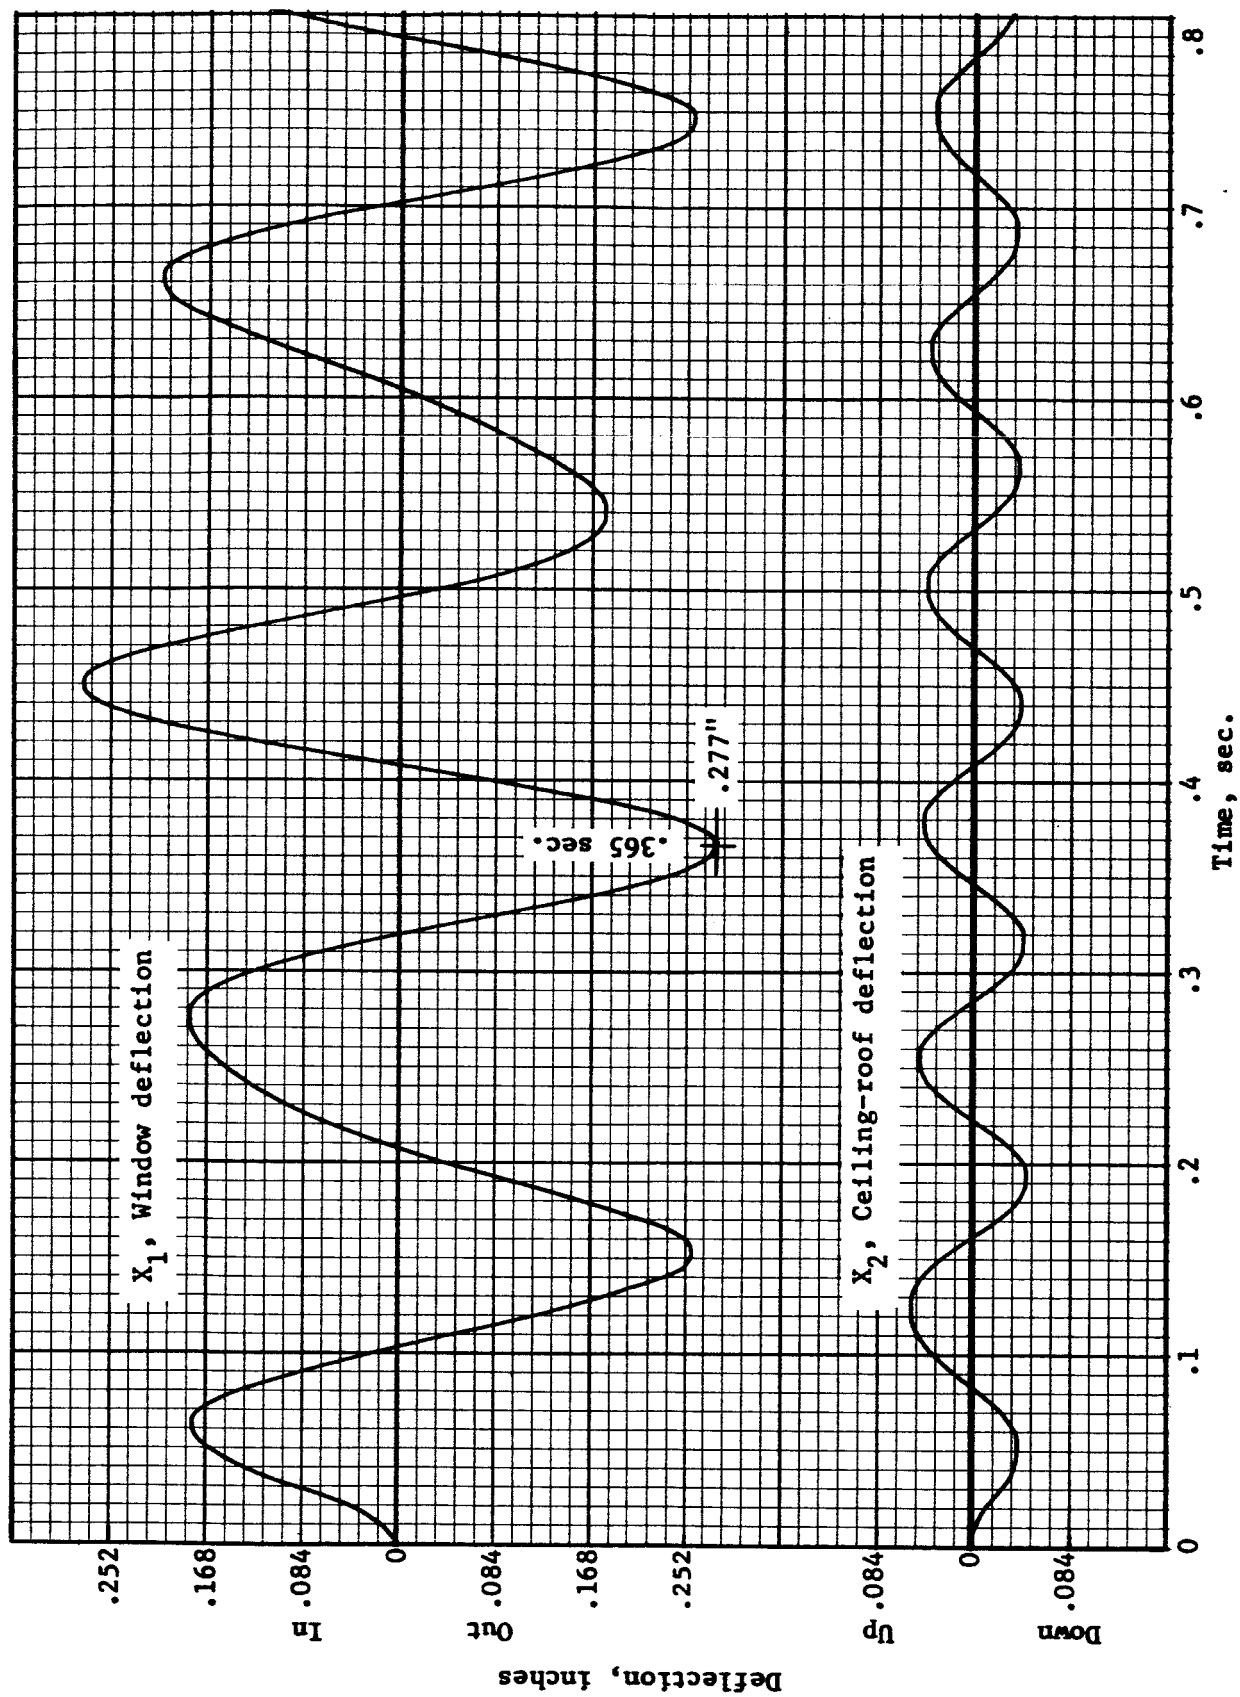
Figure 14 is a plot for $\zeta_1 = .01$, $\zeta_2 = .05$. The peak response is only slightly less (.27") but it occurs on the first outswing of the window instead of the second. It should be taken into consideration that the damping factor of the roof structure probably varies as a function of temperature and moisture content of the wood. The two values used here are probably as low as could be expected.

Figure 14 - Computed window and ceiling-roof response for given N wave. Damping ratios ζ_1 and $\zeta_2 = .01$.

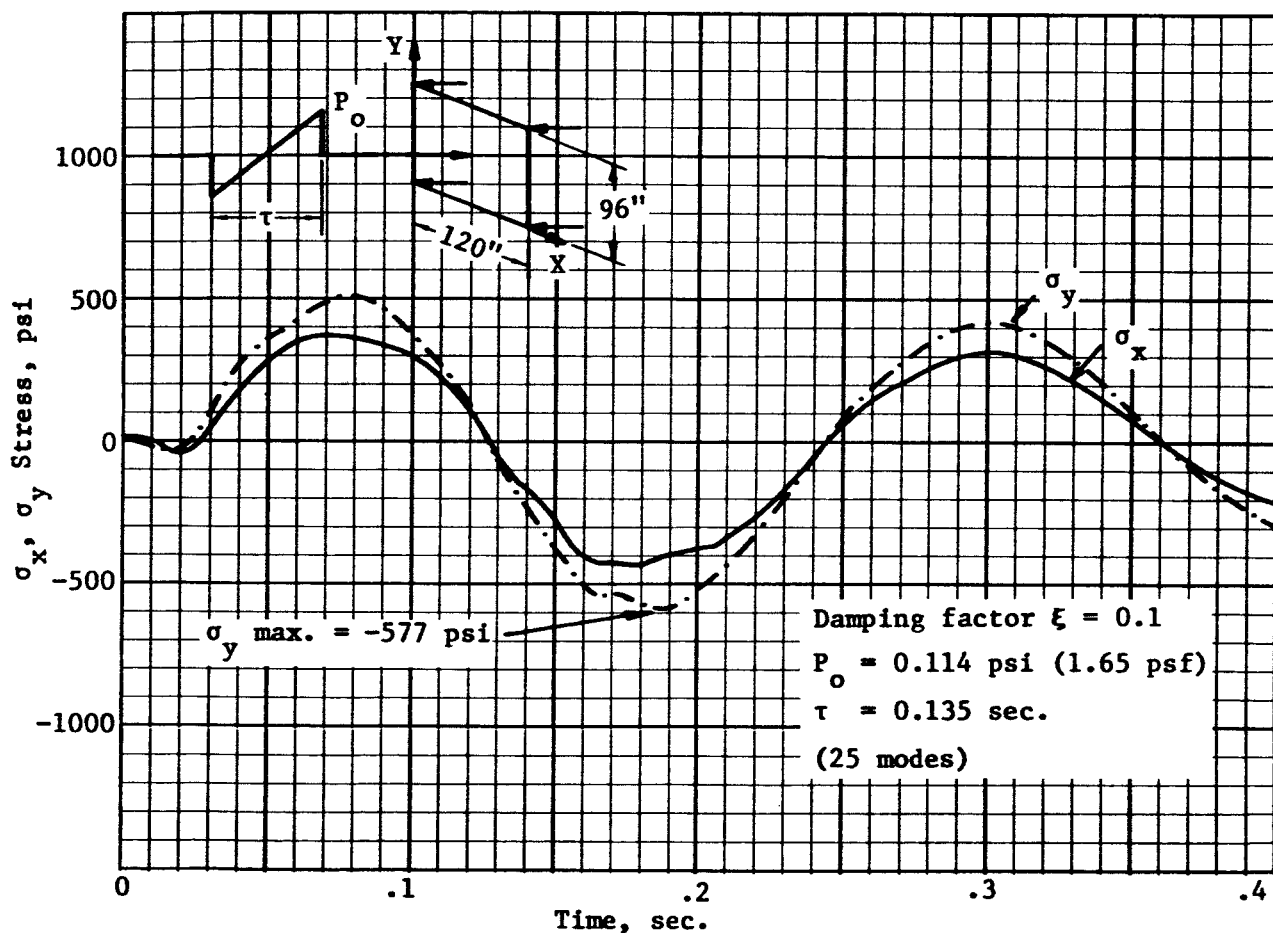
Figure 19 is a stress vs. time history for the window for an overpressure of 1.65 psf and a damping ratio of .1. The first 25 modes were taken into consideration. The stress is greater in the y direction with a peak value of 577 psi occurring on the first outswing of the window. The plot closely resembles a pure sine wave although the presence of some higher modes can be detected. The lack of high frequency content is probably due to the low value of $\frac{\tau}{T}$.

Figure 19 - Stress vs. time history at center of window for N wave at normal incidence.

In the analogue study, the resultant peak stress was found to be approximately 470 psi, which is low compared with the normally accepted value of 6,000 psi allowable stress for plate glass.
